# **GOLD FLASH CONTACTS: SUPER SAVER OR TICKING TIME BOMB**

**Max Peel**

**Contech Research, Inc.**

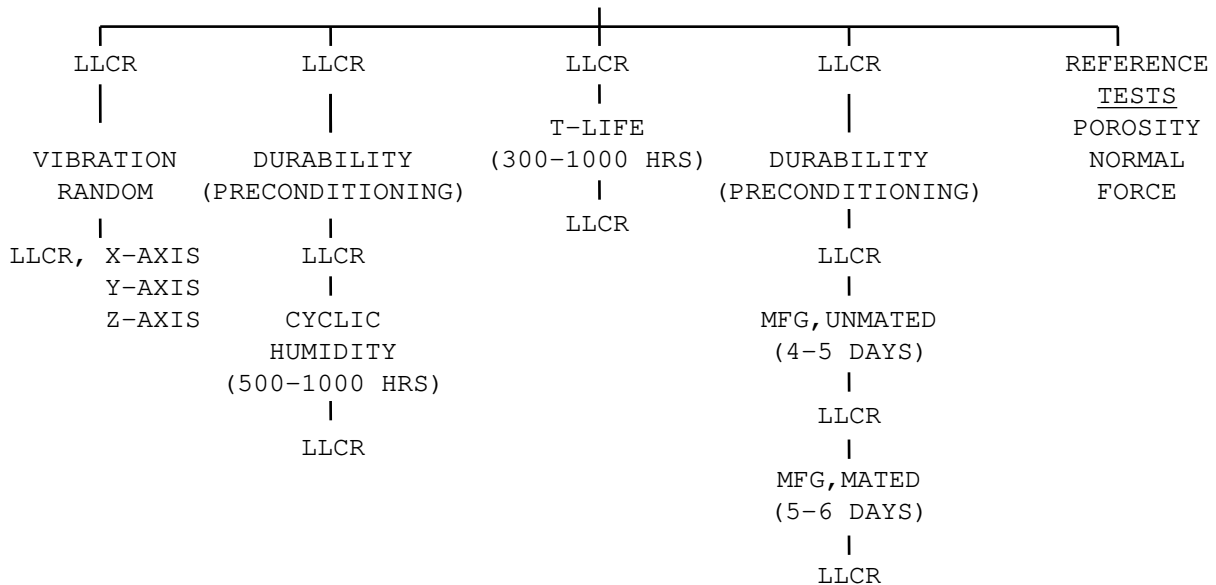
MINIMUM TEST PLAN

A vehicle to evaluate gold flash performance is shown in the following minimum test schedule.

LLCR: Low Level Circuit Resistance  
MFG : Mixed Flowing Gas

The above plan can be modified or expanded contingent of application specific situations or based on generic product families. Each of the above test groups addresses different basic failure mechanisms as follows:

- Vibration : Fretting corrosion induced by mechanical stress.
- Durability : To simulate wear normally expected in the use of the product (should not be an arbitrary number).
- Cyclic Humidity : Fretting corrosion induced by thermal excursions, wet oxidation processes.
- T-Life : Dry oxidation processes, diffusion or migration mechanisms.
- MFG : Corrosion, pore or edge creep.
- Reference Test : Attribute determination to allow the monitored data to be viewed in proper perspective.
